STATE OF HAWAII
DEPARTMENT OF LAND AND NATURAL RESOURCES
Division of Aquatic Resources
Honolulu, Hawaii 96813

SUBJECT: (1) Report and Assessment of Coral Damage of the Keawakapu Artificial Reef Incident; (2) Evaluation of the Coral Damage; and (3) Issuance of a Fine Against American Marine Corporation for Damage to Coral, Live Rock and the Environment on Unencumbered Submerged Lands in the Conservation District

DATE OF INCIDENT: December 2, 2009

LOCATION OF DAMAGE: Keawakapu Reef, Maui, Hawai'i

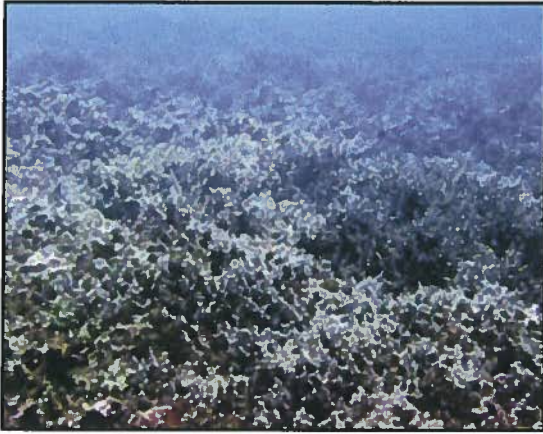
Overall, the assessment results suggest that the impacted coral reef habitat should be classified as having a medium coral ecosystem value. This reef classification is made based on coral complexity, vertical reef structure, and the percent of living coral cover. Based on detailed analysis of digital benthic photoquadrats, the average live coral percent cover value was determined to be 48%. This is a typical value for a deepwater monotypic finger coral (*Porites compressa*) reef. Along the leeward coast of Maui, in water deeper than 40', the lack of regular wave energy allows these finger coral reefs to grow fairly high with individual finger projections increasing in distance from one another. In this way the reef creates "dead" spaces between each coral finger. Some of these dead spaces fill in with small coral recruits or other crustose coral species, eg. rice coral, (*Montipora spp.*) and corrugated coral, (*Pavona varians*). However, much of these dead spaces fill in with either turf or coralline algae (Figures 3 & 4).

The impacted reef habitat did have fairly high vertical structure with an average rugosity measurement of 1.68. This value is consistent with a high coral value reef, but in this case, the structure was not composed of large crevices, cracks and mounds of coral. Instead the value was high because of the many small vertical peaks from the finger coral itself which offer limited shelter for most fish species. Most importantly, however, is the fact that critical large lobe and branching coral species were nearly non-existent. Large corals classified as having high ecological service value (lobe and branching coral colonies >80cm) accounted for only 1% of all the coral colonies surveyed. Medium ecological service value corals (lobe and branching corals 20 – 80cm, and finger corals >20cm) accounted for 22% of the reef, while the majority of the corals observed (77%) were classified as having low ecological service value (encrusting coral species and all other corals <20cm in size). Corals of this type provide little vertical structure and therefore provide a lower value habitat for other reef animals. This classification of medium reef ecosystem value, does not, however mean there are not any valuable ecosystem services provided by this type of reef habitat. For example, deeper water finger coral reefs of this type

Figure 3: wide angle view of the Keawakapu finger coral reef.

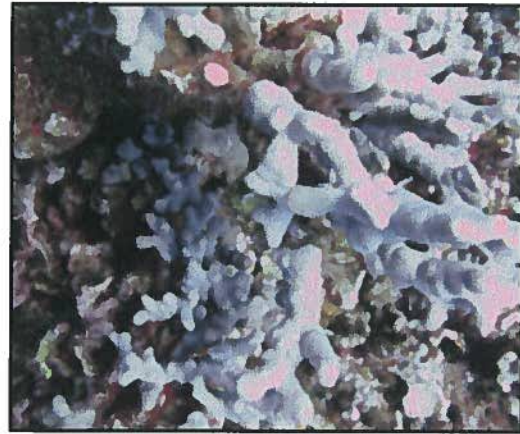
Figure 4: Close up look at the dead spaces filled with small crustose corals, turf and coralline algae.
